Flying Empires

Short 'C' class Empire flying boats

Written by Brian Cassidy
3 Queen's Parade BATH BA1 2NJ UK.

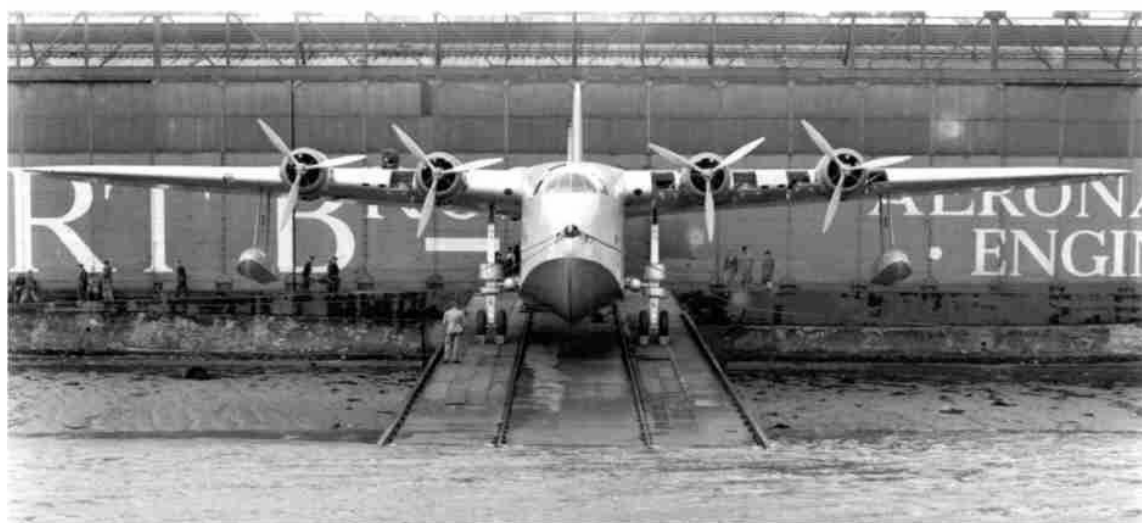
1. **Short Bros. photo H 902(d).** The then un-named G-ADHL, newly rolled-out and lashed down on the famous slipway outside No. 3 Erecting Shop at the Seaplane Works, Rochester awaiting its engine runs. The figure in the left foreground must surely be H.O.Short, admiring the company's handiwork.

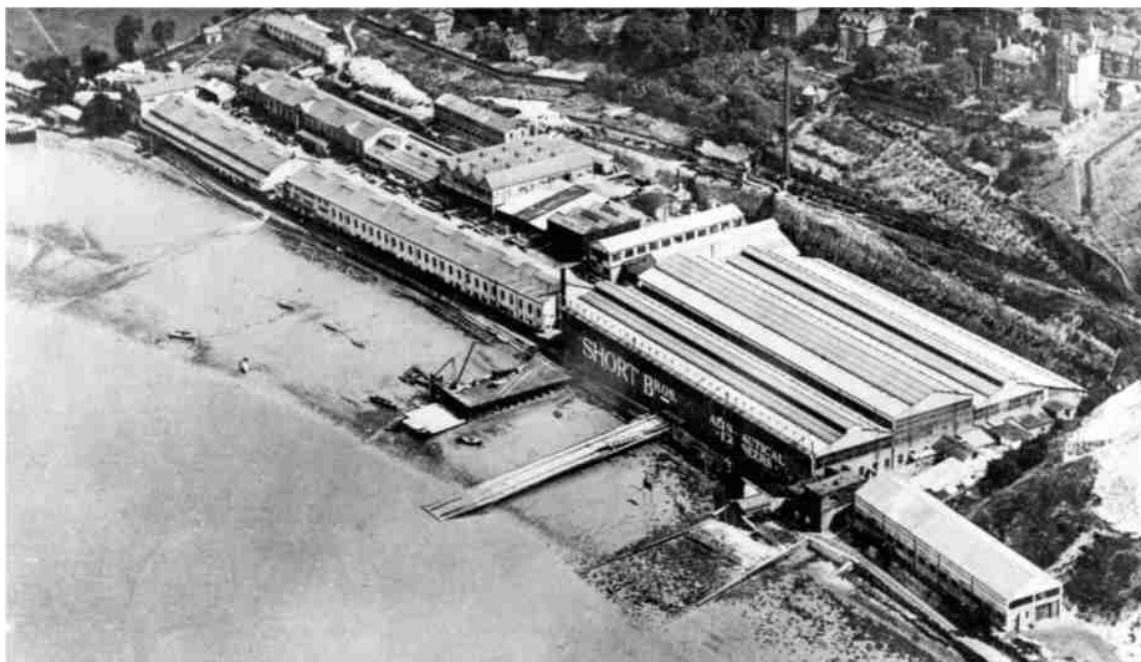
2. Short Bros. photo 75675. An aerial shot of the Seaplane Works taken from the west. From top left to bottom right along the river bank are Nos. 1, 2, 3 and 4 Shops. No. 3 Erecting Shop is the largest of the four. The end of the chalk dump is seen on the far right, behind No.4 Shop. The tide is out showing the slipway spanning the Medway mud to the water's edge. The Medway Tower, soon to be demolished, is still in place between Nos.3 and 4 Shops.

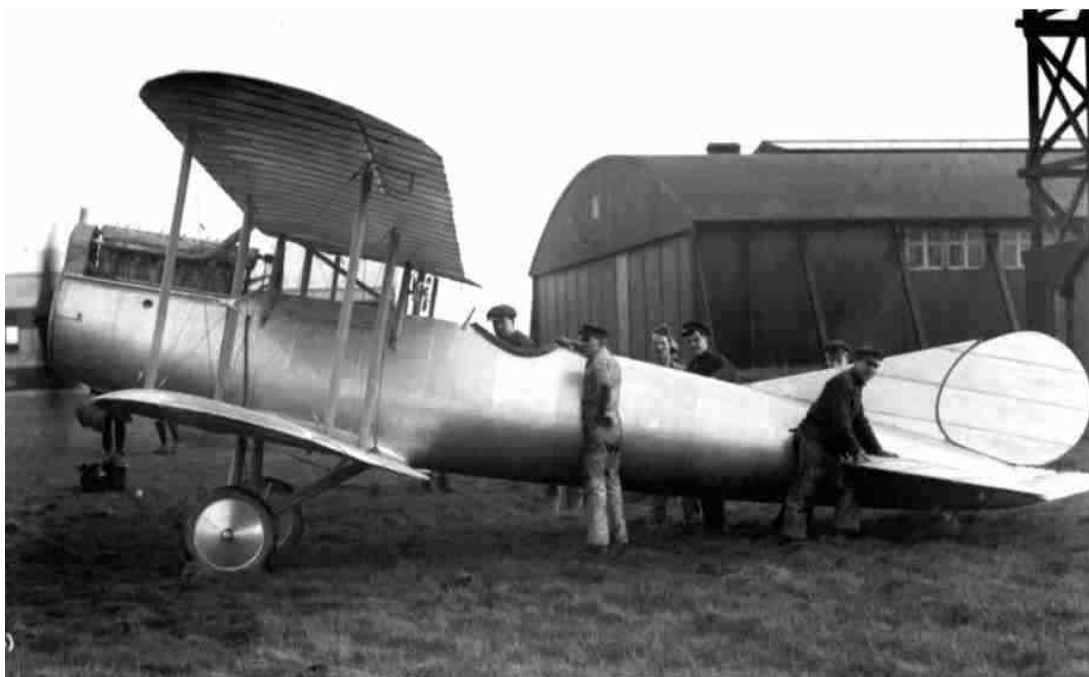
3. **Short Bros. photo H 23 (b).** The Silver Streak in original single seat form The lower case suffix attached to Short Bros. photographs. (b) in this case, usually indicated that the photograph formed part of a series taken for record purposes before, or sometimes during, the first flight of a newly completed aircraft.

The Swallow's wing spars were of steel tube with duralumin-plate ribs and built-up box ribs as compression struts between the spars. The covering was of sheet aluminium in flanged, chordwise strips joined at the ribs. The fuselage was a shell of duralumin plates riveted to L-section, oval shaped frames. The longitudinal stiffeners were cut and fixed between the frames, rather than notching the frames to allow the longerons to run through continuously. This established a principle of construction - the un-notched frame - that was maintained through to, and beyond, the Empire 'boats.

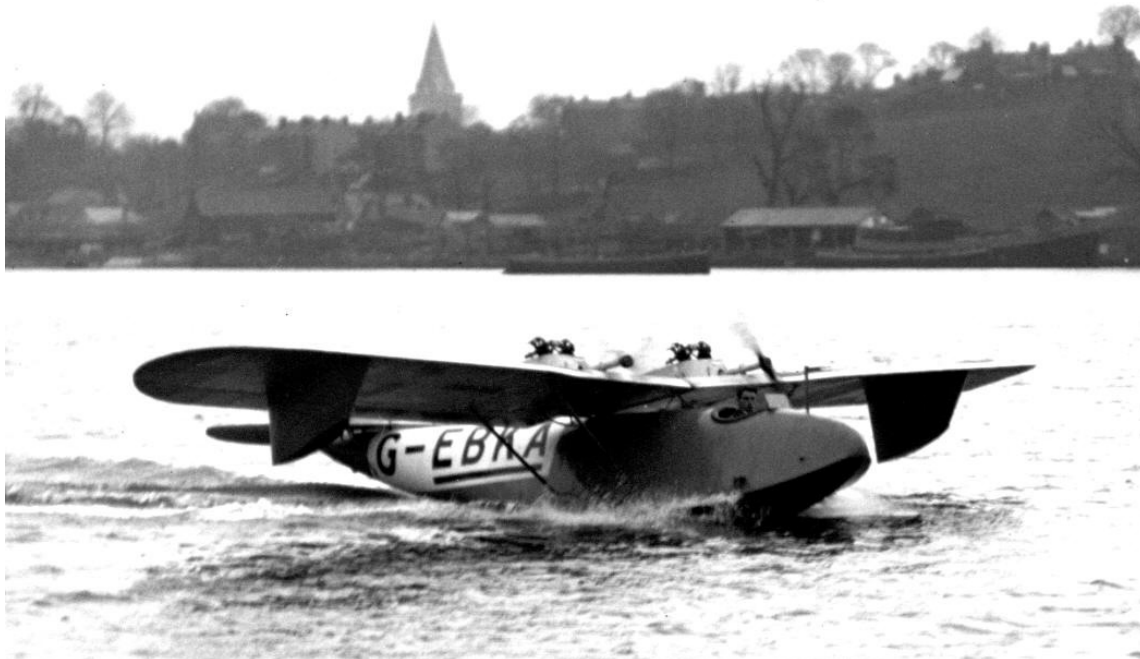
4. Short Bros. photo.H 75 (c). The Cockle motoring along on the Medway with John Lankester Parker in charge, possibly on its first outing on 18 September 1924. JLP tried for thirty-three minutes to take-off without success.

The power loading - weight of the aircraft in lb.divided by available power in hp.- of the Cockle was 48.3, the contemporary Short S.2, 19.37 and the standard S.23 Empire boat, 11.13. Finally, with the wing at a revised incidence of 7 deg. and with John Lankester Parker wearing lighter-weight trousers and gym shoes, the Cockle was persuaded off the water and flew for ten minutes on 7 November - the first metal hulled flying boat in the world to do so. The maximum speed when it did finally get into the air, was a bare 50 knots. Mr Horden declined to take delivery of his 'boat.

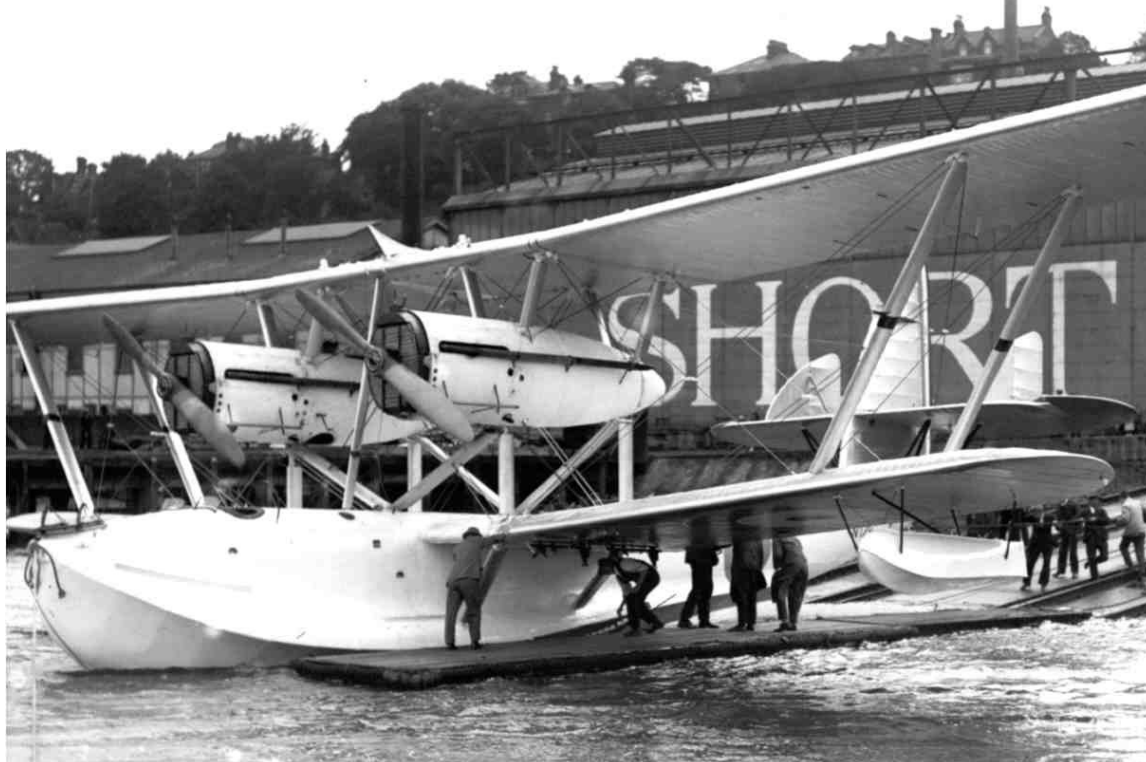
5. **Short Bros. photo. H.137(g).** Singapore I N 179 at the foot of the slipway on 17 August 1926. The public footpath running along side the River Medway enabled members of the public to watch the launching.

The Singapore I - RAF serial N 179 - was Short Bros' third duralumin hull and the first to be developed in the Rochester testing tank. The remainder of the Singapore I's aerostructure did not greatly influence the design of the Empire 'boats, except that it was metal-framed with Frise ailerons on set-back hinges, on the upper mainplanes for the first time. N 179 had a span of 93ft (28.35 m.), was fitted with two Rolls-Royce Condor IIIA engines of 705 hp. (525 kW.), had an all-up weight of 19 560 lb. (8 700 kg.) and a maximum speed of 111 knots. N 179 was launched on 17 August 1926, first flown by John Lankester Parker and subsequently delivered by him to the MAEE at Felixstowe for its service trials. At the time of the launch, the Singapore I was the largest metal hulled flying boat in the world. The aircraft underwent various modifications to its tailplane and engines, and with its up-rated Rolls-Royce Condor engines and modified form, set out on the RAF Scandanavian cruise starting on 12 August 1927. It was in company with the Blackburn Iris II N 185 - metal hull and timber aerostructure, the all-timber Saunders Valkyrie N 186 - with a 'Consuta' copper-stitched plywood hull - and Supermarine Southampton I N 218 with a timber hull. The metal-hulled boats completed the 4 378 n.m. (8 000 km.) circuit round the Scandanavian ports without major incident.

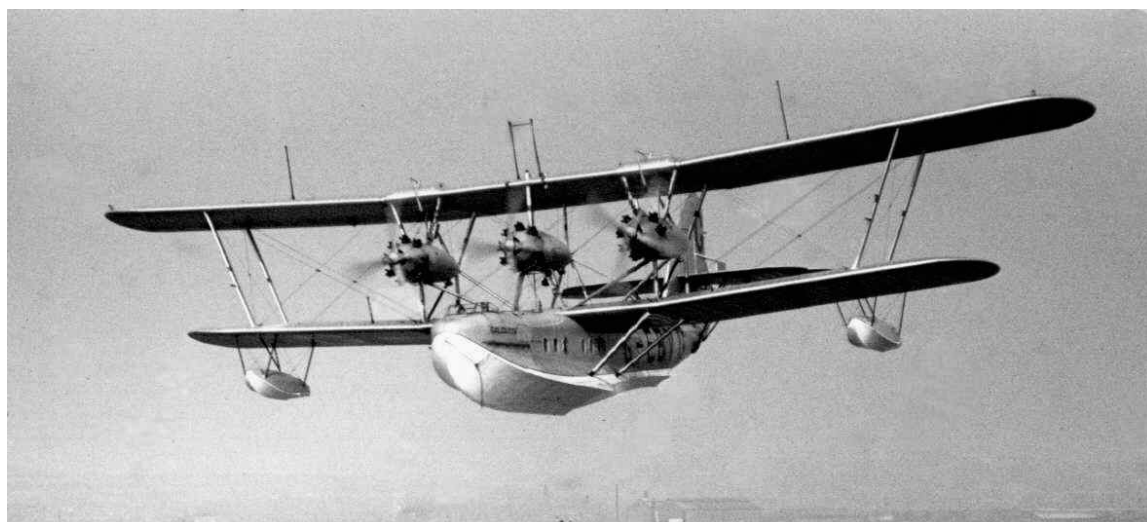
6. Short bros. photo H 243 (j). Short Calcutta G-EBVG over the Medway. The lines of the hull and planing bottom are seen to advantage. 'VG capsized in a storm at Mirabella 28 December 1936.

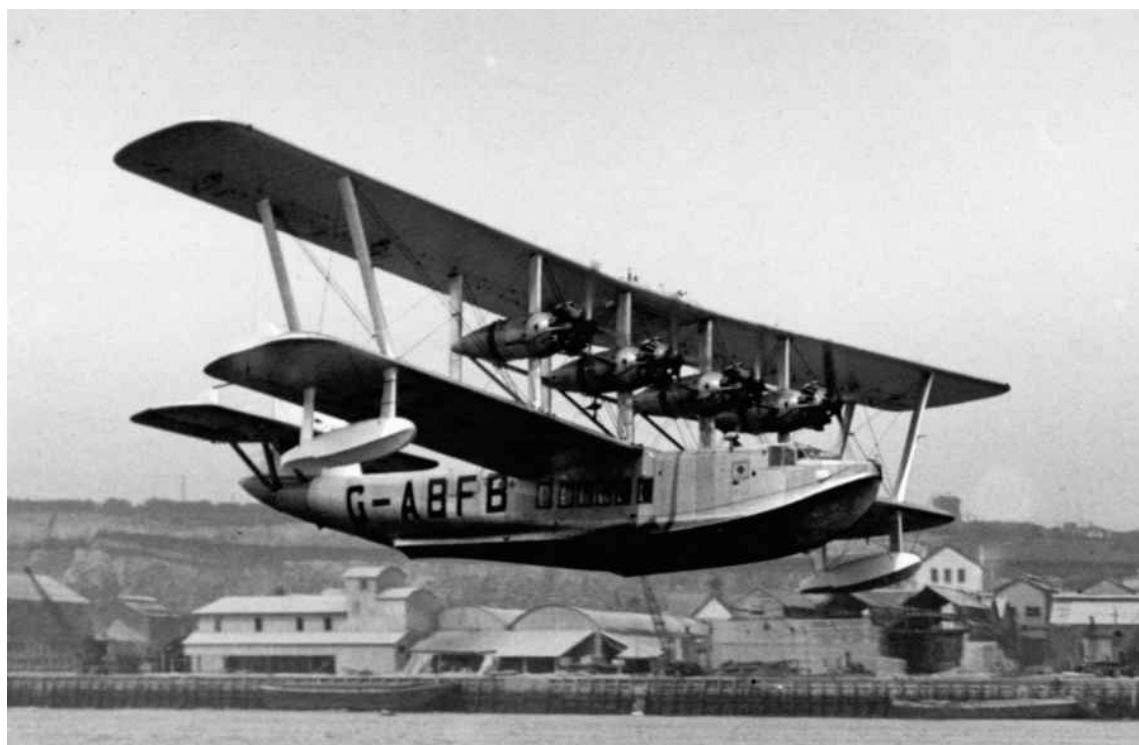
7. Short Bros. Photo. H.473(d). The second Short Kent G-ABFB , later named Sylvanus, over the Medway on 31 March 1931. 'FB was destroyed by fire at Brindisi on 9 November 1935.

The construction of the hull - the seventh Short Bros. metal hull - generally followed that of the Calcuttas. The planing bottom was in stainless steel in the manner of the Singapore II, with a transverse main step. Bi-metallic corrosion problems arising from the Singapore II hull had been solved, so Short Bros. became the first company to master the technique of building seaplane floats and flying boat hulls in this combination of metals.

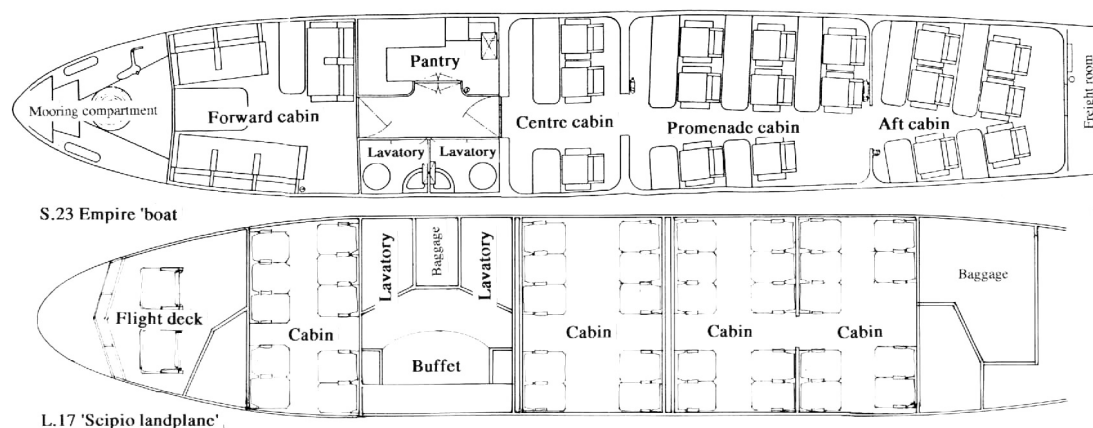
8. Accommodation plans of the L.17 and S.23 compared.

Time was short, so a heavier braced-frame structure was used for the fuselage of the L.17s in place of a lighter monocoque, which would have taken longer to design. The passenger accommodation was a forerunner, almost a prototype, of that used later for the S.23s. The cabin mock-up was ready by April 1933.

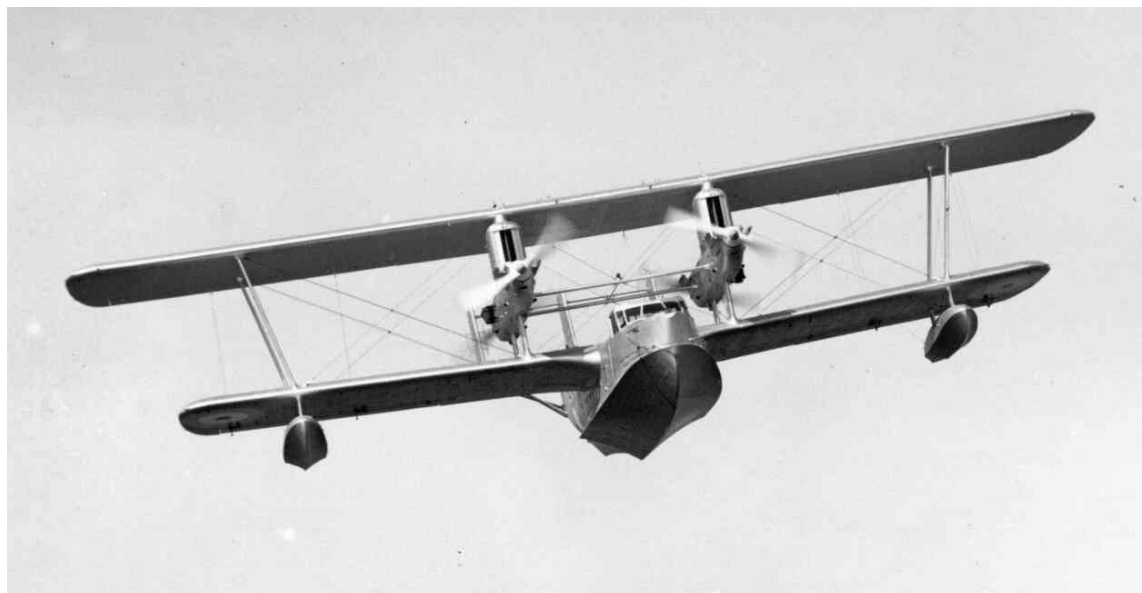
9. **Short Bros. photo H 668 (d).** A superb shot of a Short Singapore III, probably K 3592 taken in June 1934 on its first flight. K3592 was ferried by 210 Sqdn personnel to reinforce 205 Sqdn. at Singapore, arriving 5 March 1935.

The Short Singapore II was developed into the Singapore III. The first - Construction number S. 770 with RAF serial K 3592 - was on the slipway outside No.3 Shop on 15 June 1934 and the last of batch was launched on 11 November. A further batch of nine production aircraft to Specification R14/34 was followed by an additional sixteen 'boats'. The production was completed in June 1937, with four more, these 'boats' sharing No. 3 Shop with the first fifteen Empire 'boats' off the line and the Sunderland prototype.

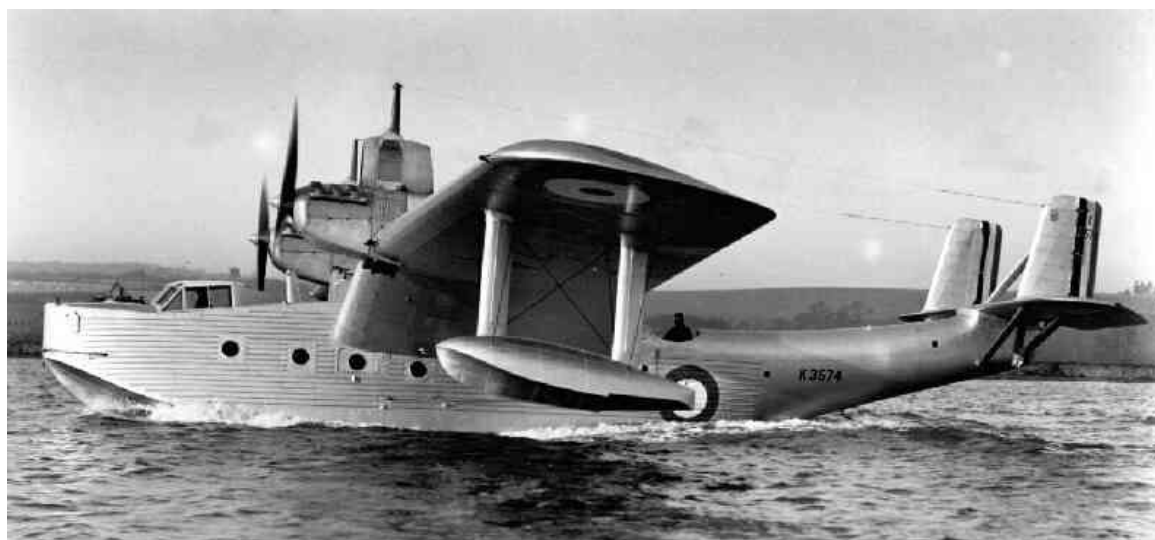
10. Short Bros. photo H 618 (b). The Short R 24/31 K 3574 Knuckleduster taxiing on the Medway, November 1933. The high set Rolls-Royce Goshawk engines are evident. The aircraft is in its original form with un-sprung wing tip floats and open tail gunner's position. K 3574 was retired in 1938 to become an instructional airframe at the RAF No. 2 School of Technical Training at Cosford.

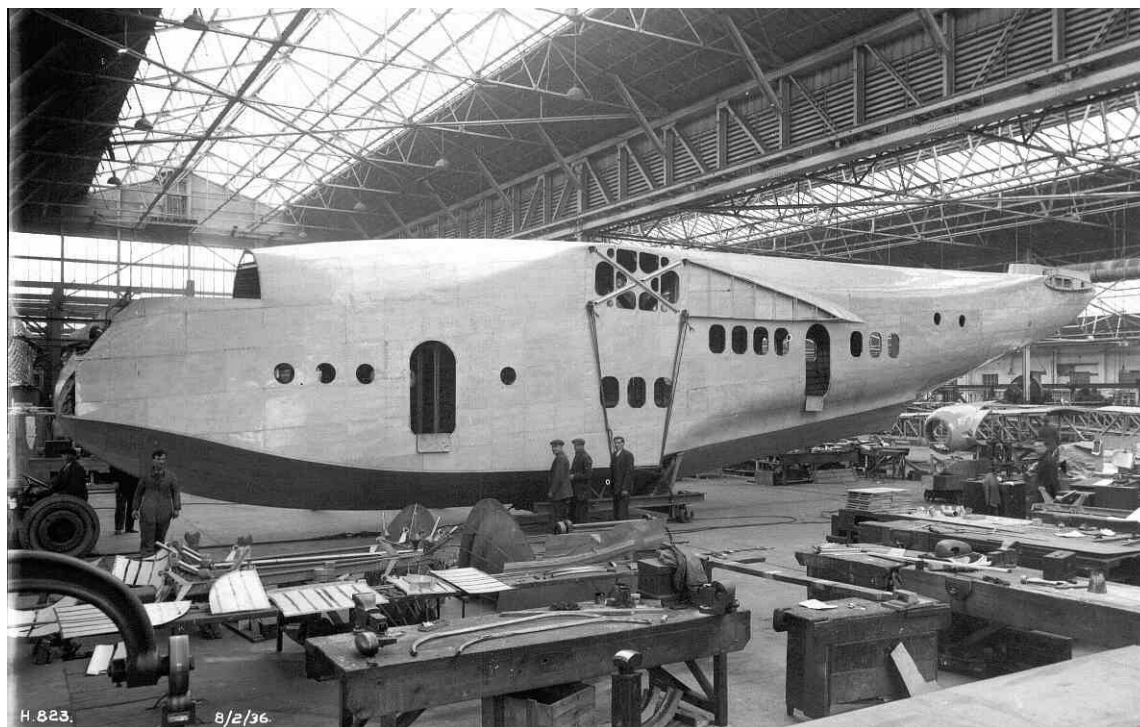
11. Short Bros. photo 832. 8 February 1936. The hull of the first Empire 'boat - minus the coupé, but mated with the tail aft of Frame 42 - newly withdrawn from the gantry, perched on the shop truck. The hull has been turned on to the centre line of the main doors of No. 3 Shop with the nose pointing towards the main doors, ready for eventual roll-out. The date is 8 February 1936 and the time, 16.15. The starboard half mainplane is evident to the right of the photo, beneath the tail.

The maximum beam dimension of all Empire 'boats was 10 ft. (3.05 m.). Obeying the 'law', the beam of an S.23 should have been 12.36 ft. (3.77 m.). For an S.30, loaded to 48 000 lb. (21 772 kg.) it should have been 13.08 ft. (3.98 m.) and at the extreme displacement of 53 000 lb. (24 040 kg.), the beam should have been 13.52 ft. (4.12 m.). For comparison, a Felixstowe F.5. with a loaded weight of 12 700lb. (5 760 kg.) had a beam of 20 ft. 4 ins. (6.2 m.).

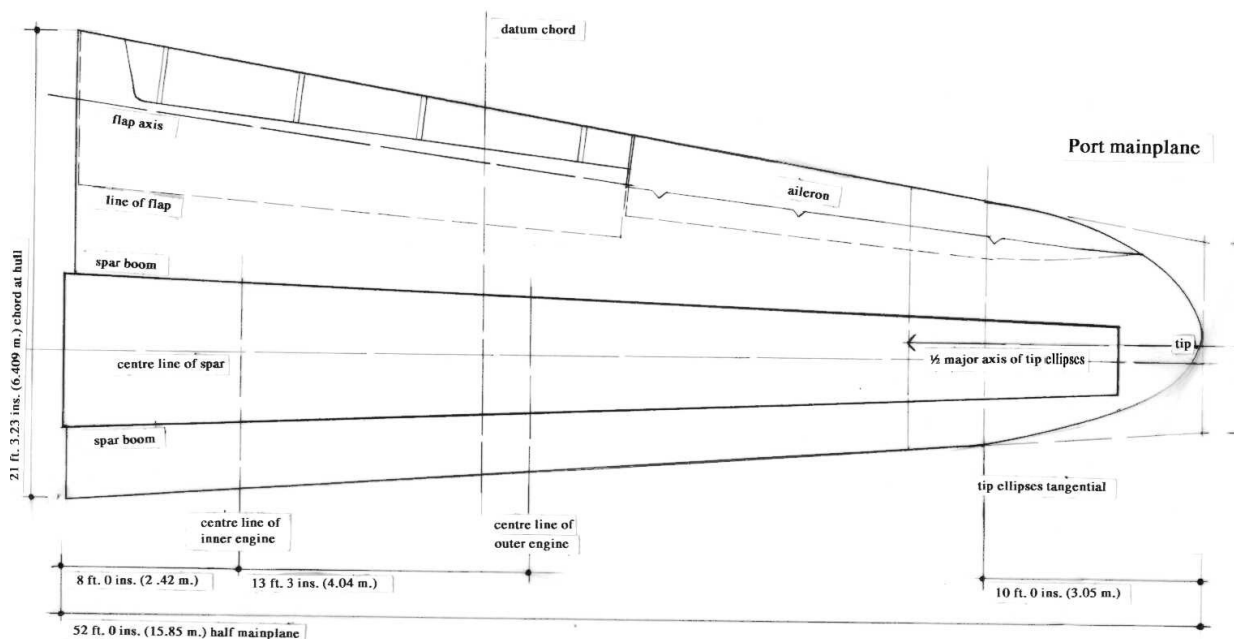
12. Diagram of mainplane geometry.

The Empire 'boat was the third Short Bros. design for a monoplane flying boat. The span of 114 ft. (34.75 m.) was constant for all types - S.23, S.30 and S.33. The gross area of the mainplanes for all types was 1 720 sq. ft. (160 sq. m.) with a nett area including the flaps, ailerons and nacelles of 1510 sq. ft. (140 sq. m.) - normally quoted as 1 500 sq. ft. (139 sq.m.). The aspect ratios were respectively 7.56 and 8.60. The datum chord measured 16 ft. 5.5 in. (5.018 m.), at a point 23 ft. 11.32 in. (7.298 m.) from the centre line of the aircraft at right angles to the plane of symmetry. The modified Gö 436 aerofoil used had a thickness to chord ratio of 18.78 % at the junction with the hull, diminishing to an hypothetical 9% thickness to chord ratio at the tip.

The spar axis was a straight line through the mid-camber points of the aerofoil at 31% chord, set at a 3 deg. dihedral. The upper surface of the aerofoil had a nominal dihedral of 1 deg. on the spar centre line.

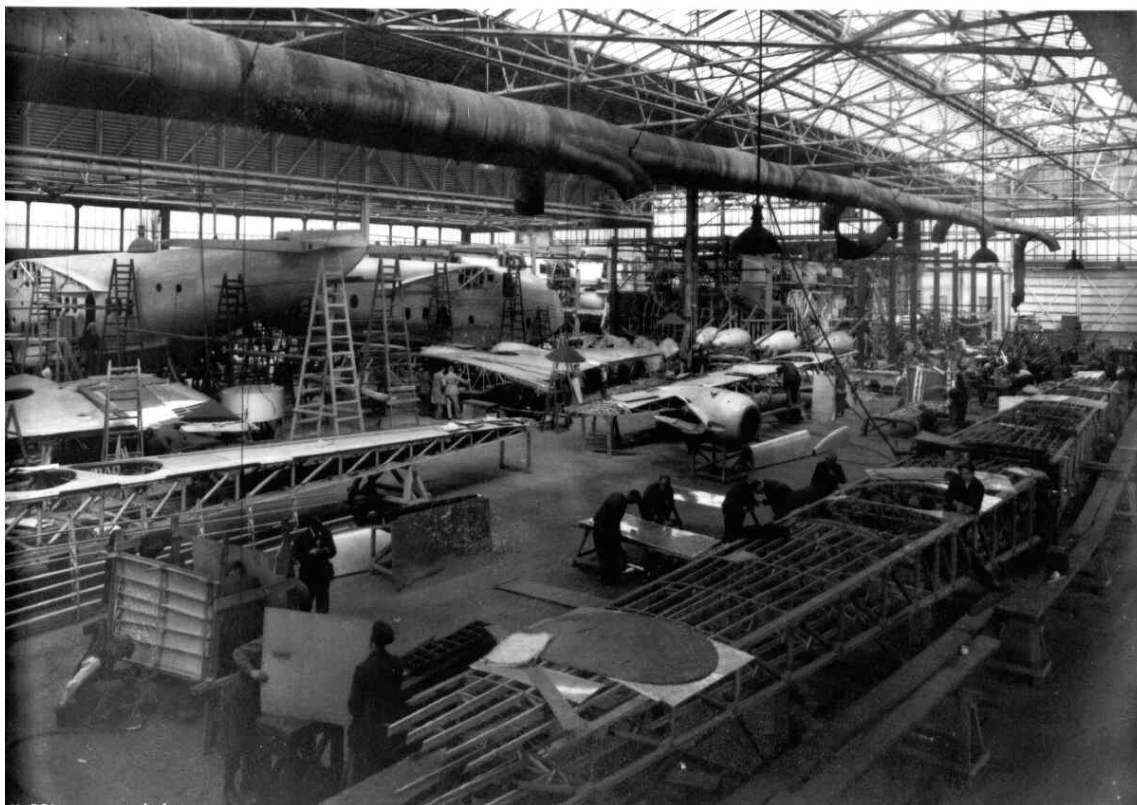
13. Short Bros. photo H 861. The completed hull of G-ADHL is in the left background, with its two half mainplanes on either side of the tail, sheeted and awaiting the installation of engines. The newly withdrawn hull of G-ADHM is in the centre background. The two half mainplanes in the centre of the photo, showing the spar truss, are for 'HM'. The mainplane spar boxes in the right foreground, ready for sheeting, are for the first Mark II 'boat, G-ADUT.

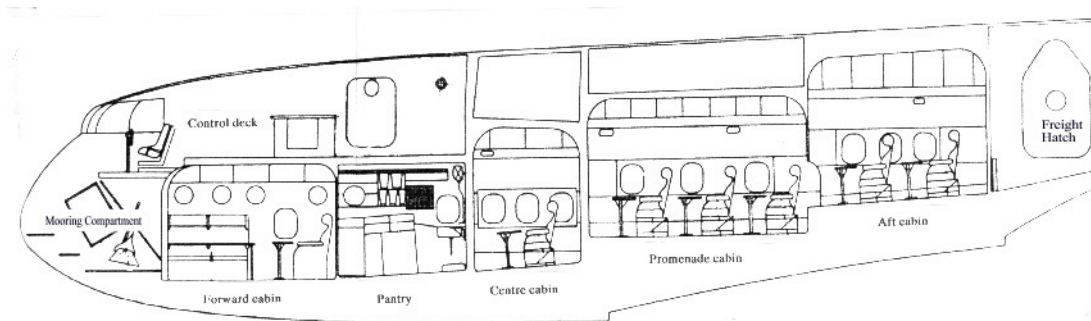
14. Section through an S.23 showing the accommodation on upper and lower decks. The pantry was on the starboard side, with the lavatories opposite on the port side. The passenger cabins show the seating on the starboard side.

The cabin between the main spar frames for example, was usually called up by Short Bros. as the 'Centre Cabin' but is sometimes referred to as the 'mid cabin' but usually known as the 'spar cabin' by the IAL crews. 'Centre Cabin' is used here. The food preparation space on the lower deck is referred to in the Maintenance Manual as the 'buffet' in some places and as the 'pantry' in others. 'Pantry' has been chosen as the most frequently used, and most appropriate, name. The toilets were known as 'lavatories' in the Maintenance Manual and are called so here.

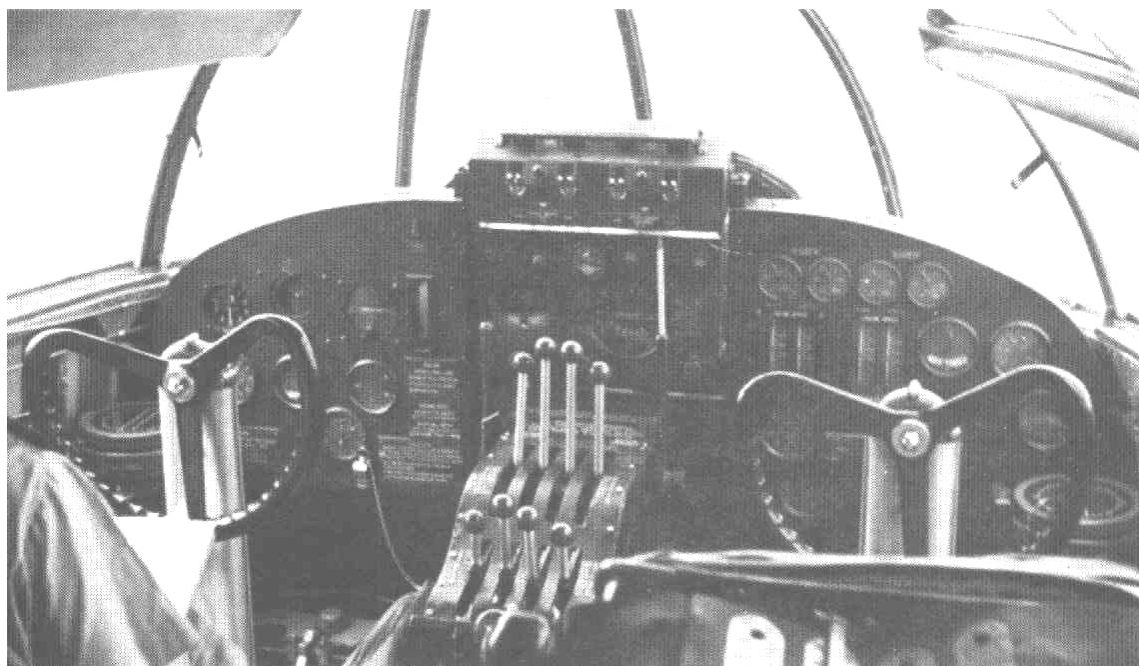
15. Captain Alderson photo. The Control Deck of 'UU CAVALIER in flight. 'UU is cruising on automatic pilot, somewhere over the Atlantic between Bermuda and the USA. The altimeter reads 9 500 ft., the oil pressures are 80 lb. per sq. in. and the engine speeds are 2 100 rev. per min. Note the whistle hung from the Captains dashboard. The unfurled blind on the port side might indicate that 'UU was on the way to Bermuda. The shoulder, on the left of the photo, belongs to Captain Alderson.

The flight crew's operating positions were in the fully enclosed cabin on the upper deck. The Captain occupied the port side pilot's seat with the First Officer beside him to starboard. The wireless station was immediately behind the Captain. The Control Deck stretched from Frame 3 - the forward point of windscreen of the coupé, - aft to the forward spar frame at Frames 15/16 - a distance of about 23 ft. (7 metres). By the standards of the day, the Control Deck was considered to be 'luxurious'. It was certainly adequately roomy and not unduly noisy, although un-lined. Bare and workmanlike might be a reasonable description. The panels of the windscreen were well rounded in both dimensions and shed the rain without recourse to mechanical wipers. Despite the Bostick and the water test, the windscreens on some of the 'boats leaked in monsoon rain conditions. The visibility from the pilot's seats through the ample windscreen forwards and to the sides was extensive - 'excellent' - was Captain J.C.Kelly-Rogers' description. The noise levels on the Control Decks of Empire 'boats and the Boeing 314As were comparable although the level of vibration on the 314As was more noticeable. The Control Decks of the two 'A' 'boats were insulated when the cabin heating arrangements were changed in late 1944 or early 1945.

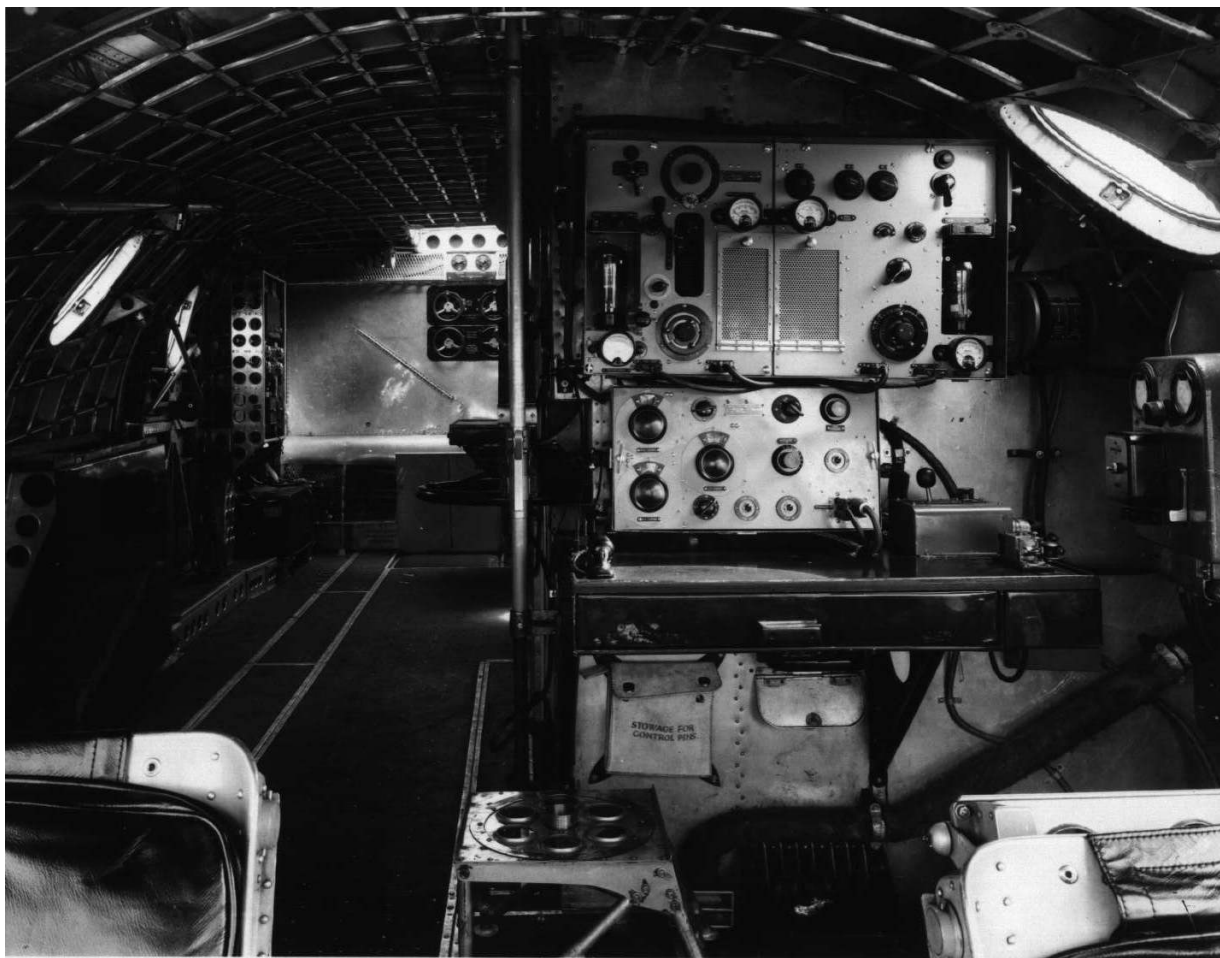
16. Short Bros. photo H 928. The Control Deck looking aft. The Radio Officer's station is on the right of the photo, showing the 1937 equipment for the normal range S.23 'boats. On the left of the photo, the Control Deck extends aft to the bulkhead at Frames 15/16. The escape hatch is OPEN. Reading down from the opening are: the Telelevel fuel tank contents gauges, the two carburettor air intake shutter control wheels and the fuel pump test cock control wheels. The fuel tank cock controls are roof mounted, to the left of the hatch opening. The main electrical switchboard and battery are to starboard, forward of the bulkhead, with the desk of the Flight Clerk's original working station, opposite. The two ports on the starboard side are in the mail loading hatch (rear most) and over the navigator's chart table (folded down).

The Radio Officer sat immediately behind the Captain on the Control Deck, facing aft. The importance of close and instant communication between the pilots as the 'eyes' of the aircraft, and the Radio Officer as it's 'mouth and ears', was crucial. The Flight Clerk's original work station on the Control Deck was soon moved down to the Forward Cabin on the lower deck, doubling as a hold for mail and freight and providing a much more convenient working position.

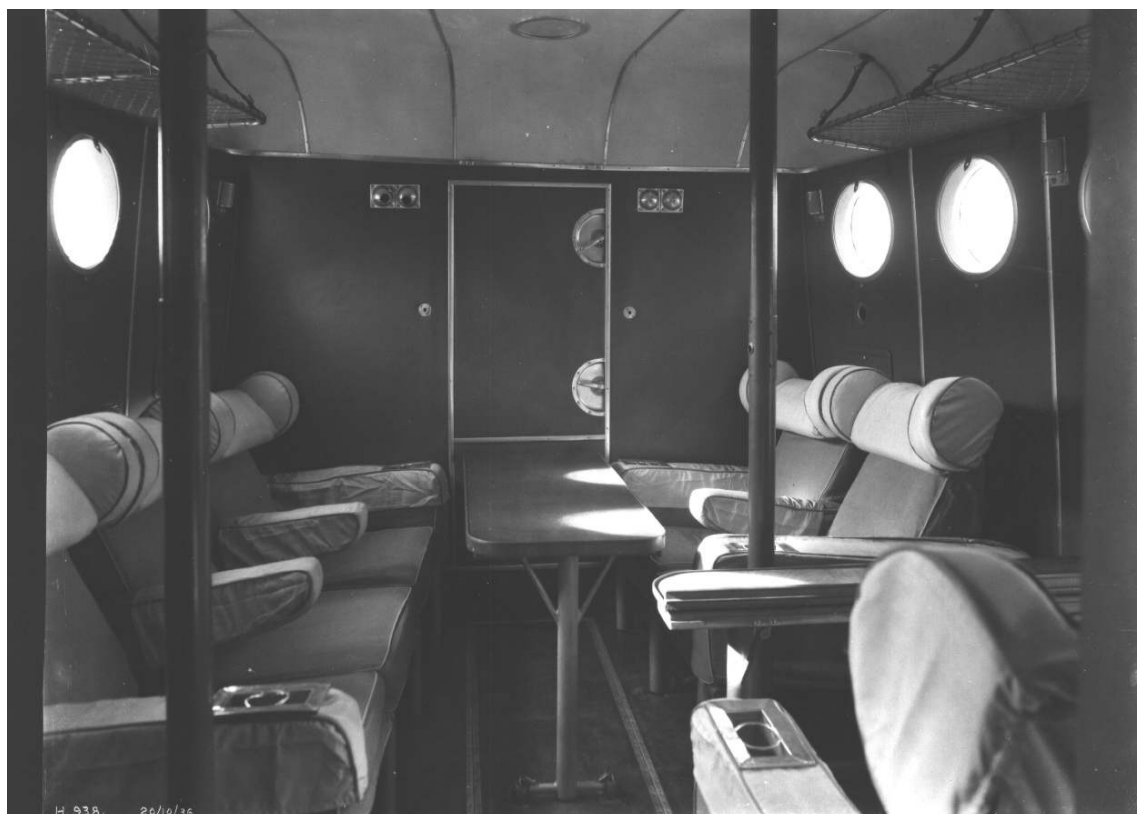
17. Short Bros. Photo H 938 20 October 1936. The forward Smoking Cabin of 'HJ CANOPUS', looking forward. The entry hatch to the mooring compartment is in the bulkhead at the end of the table, with a double cold air punkah louve unit on either side. One of the two ceiling lights is visible. The pillars took the ends of the bunks. This cabin was later converted to a mail room and office for the Flight Clerk.

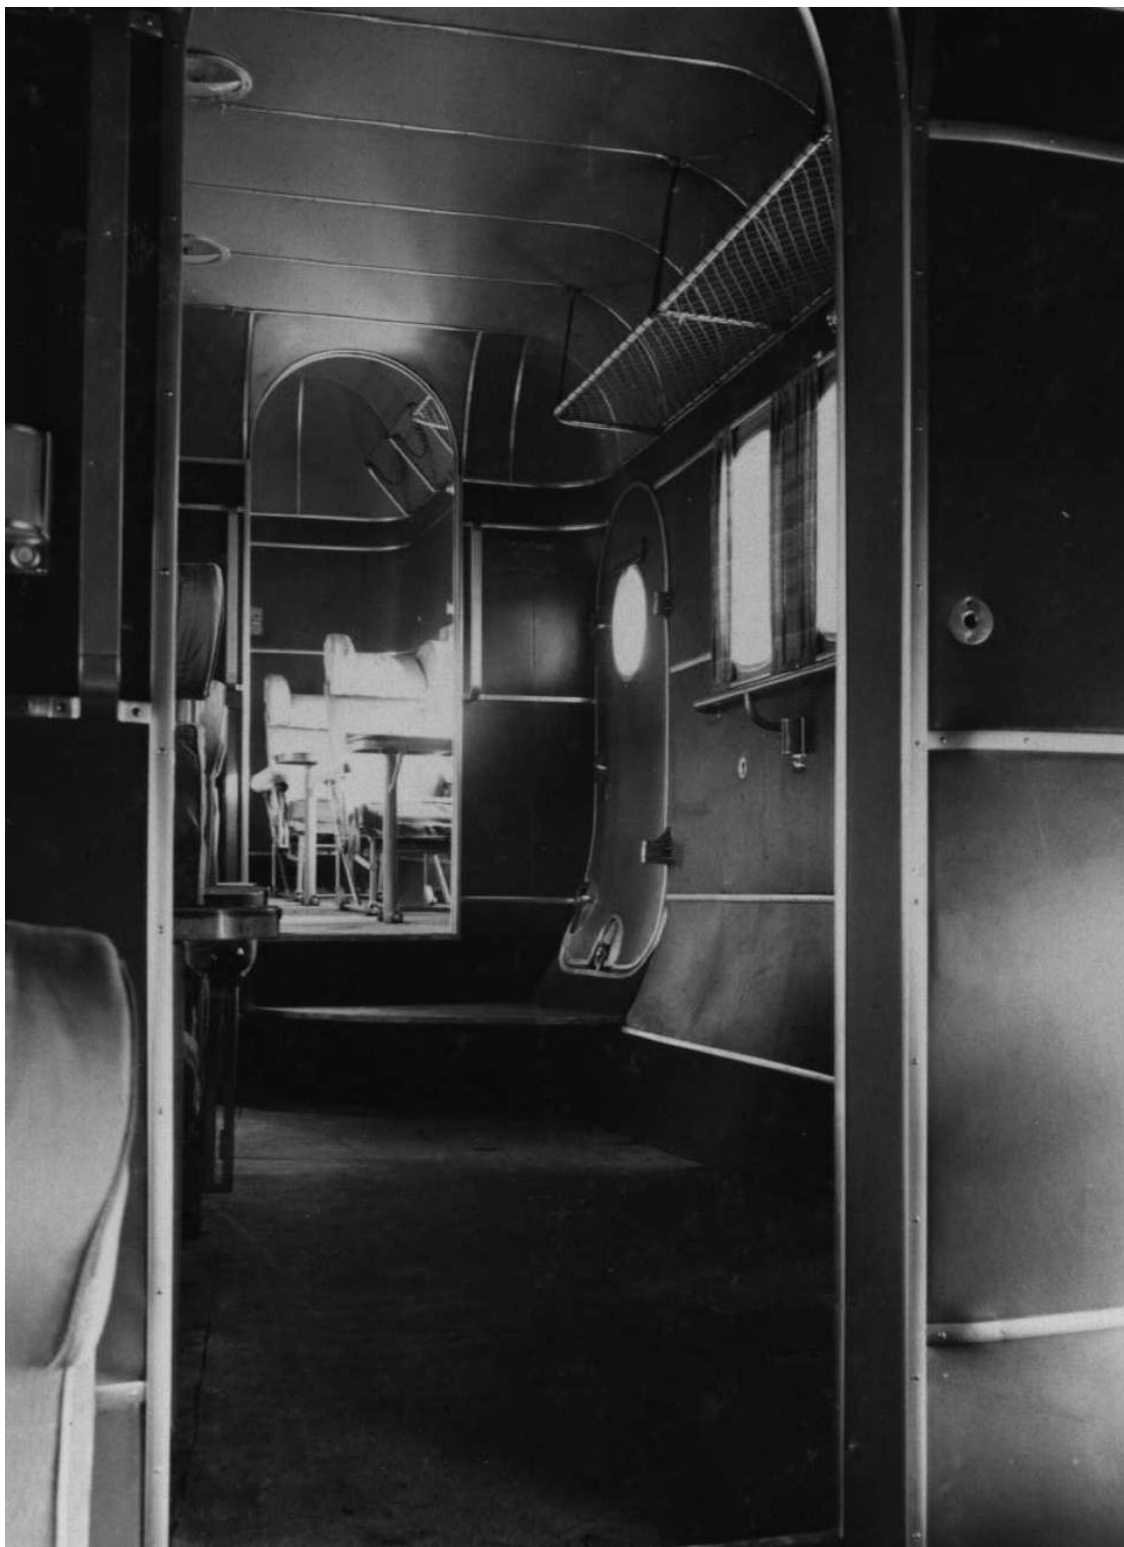
18. Short Bros. photo 8S126-3 An interior photo taken from the Centre Cabin, looking aft into the Promenade Cabin, showing the Promenade space. A combined wall and bunk light with Steward's call button is to the left of the opening. An escutcheon for the end of a bunk is to the right of the opening. The passenger entry hatch is in the centre of the photo. The Aft Cabin is in the background.

Continuing towards the rear of the aircraft, a door from the Corridor opened into the Centre Cabin, squeezed between the two main spar frames, about 6ft. 0ins. (1.8 metres) long, 9ft. 10 ins. (3.0 metres) wide and 8ft. 0ins. (2.5 metres) high. There were six windows and two bunk windows. All the windows and ports were fixed on aircraft up to the twelfth 'boat of the second batch - 'UG COOGEE. The windows were modified on the later 'boats so that all windows could be opened in emergencies. Instructions for use were fixed below each window explained that it could be opened with a sharp blow with the hand or foot towards an edge. The earlier aircraft were retro-fitted with the modified windows. Three IAL seats were fitted, two to starboard and one to port. Four bunks could be rigged. The concealed bullion locker was under the floor - approximately under the aircraft's centre of gravity. There were seven light positions with a maximum of four lights and one 36 watt ceiling light. The entry to the Promenade Cabin to the rear was one step up.

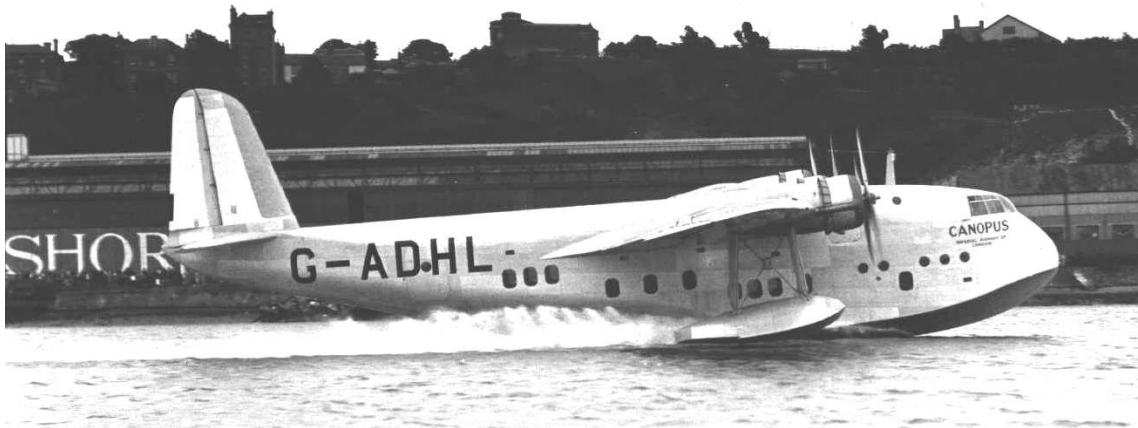
19. Short Bros. Photo H.907 (g). 'HL CANOPUS gathering speed for take off on 4 July 1936 before an assembled multitude of spectators. Note the original sprung float arrangement, the un-painted mahogany trim tab, the lack of the upper servo tab on the rudder and the original position for the owner and port of registration lettering.

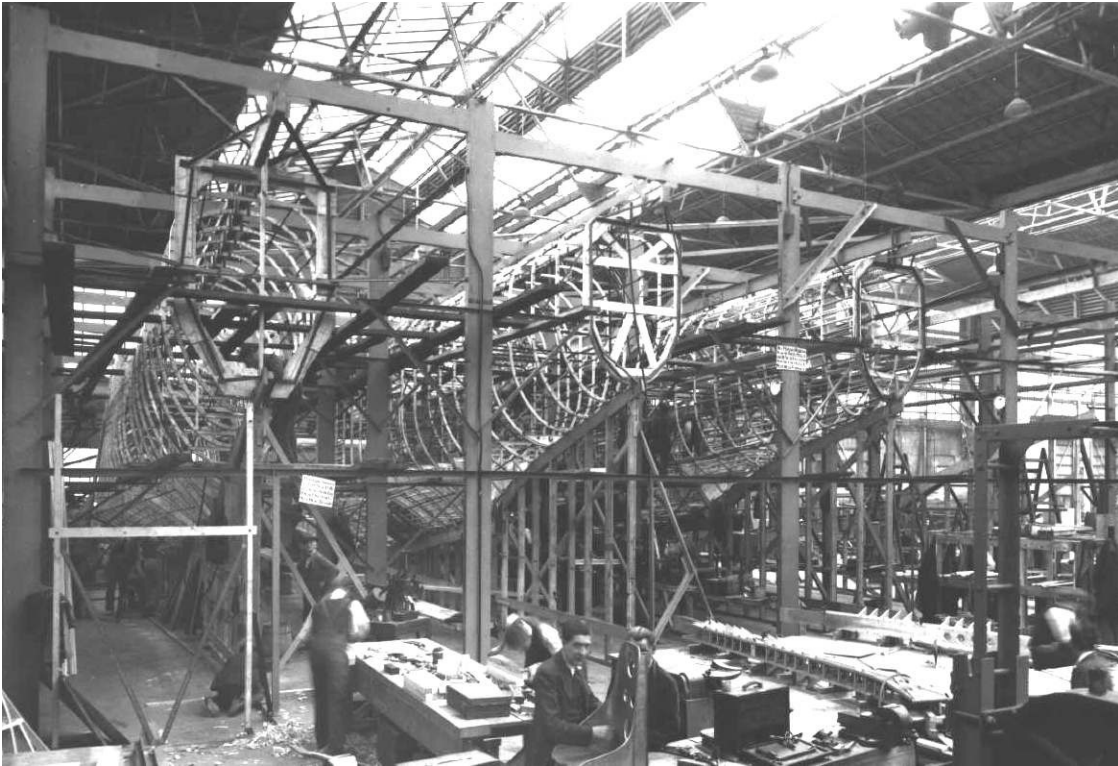
20. Short Bros. photo H 764. The first two S.23 hulls being assembled in Gantries Nos. 2 and 3. The hull in Gantry No. 1, on the left of the photo, is that of 'HK Maia. As the hull in Gantry No. 3 is the more advanced with the stiffeners in place, it is likely to be for 'HL CANOPUS. The hull in Gantry No. 2 is that of 'HM CALEDONIA. The Empire 'boat hulls ended at Frame 42, the construction joint between the hull and the tail unit. The profile board for the third S.23 hull can just be seen to the right of the photo.

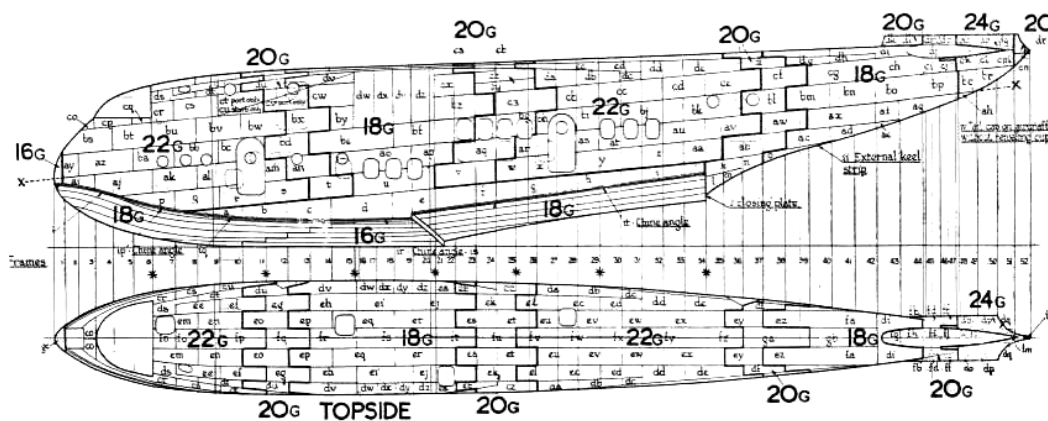
21. Maintenance Manual Diagram M 35. The hull plating and Frame positions.

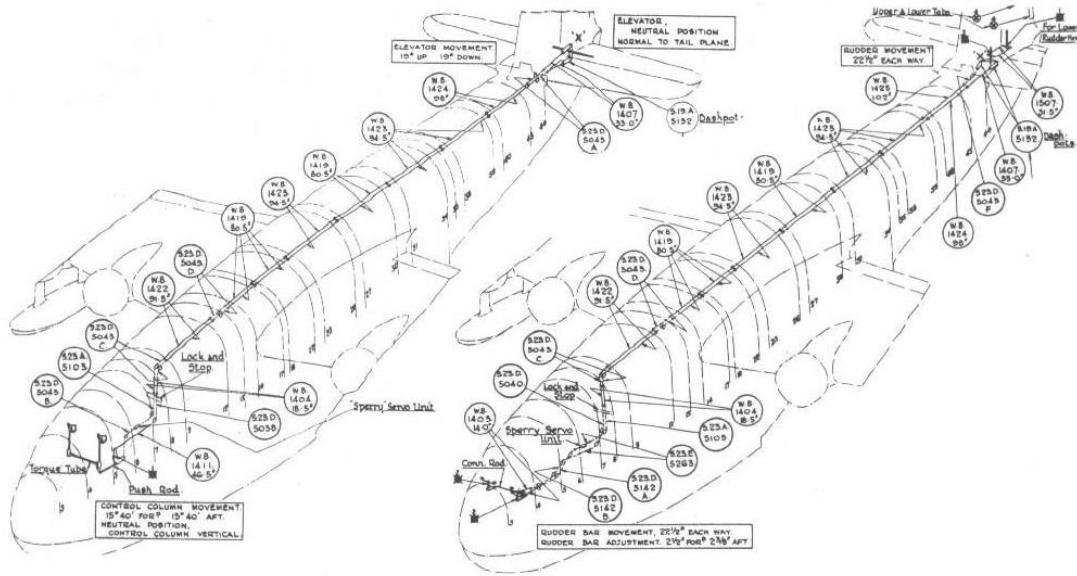
23. Parts of Maintenance Manual Diagrams 4 and 5 showing the rudder and elevator control runs.

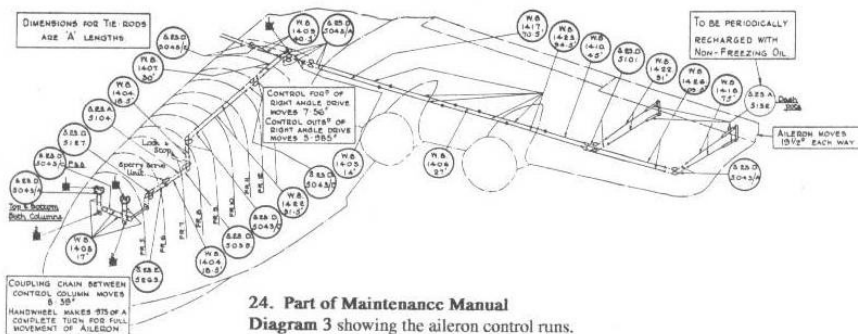
24. Part of Maintenance Manual Diagram 3 showing the aileron control runs.

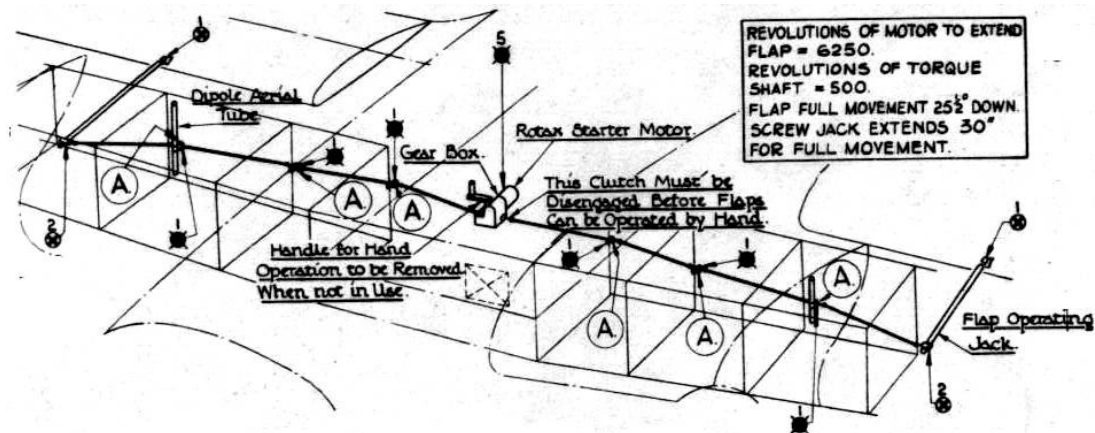
25. Part of Maintenance Manual Diagram 27 showing flap controls.

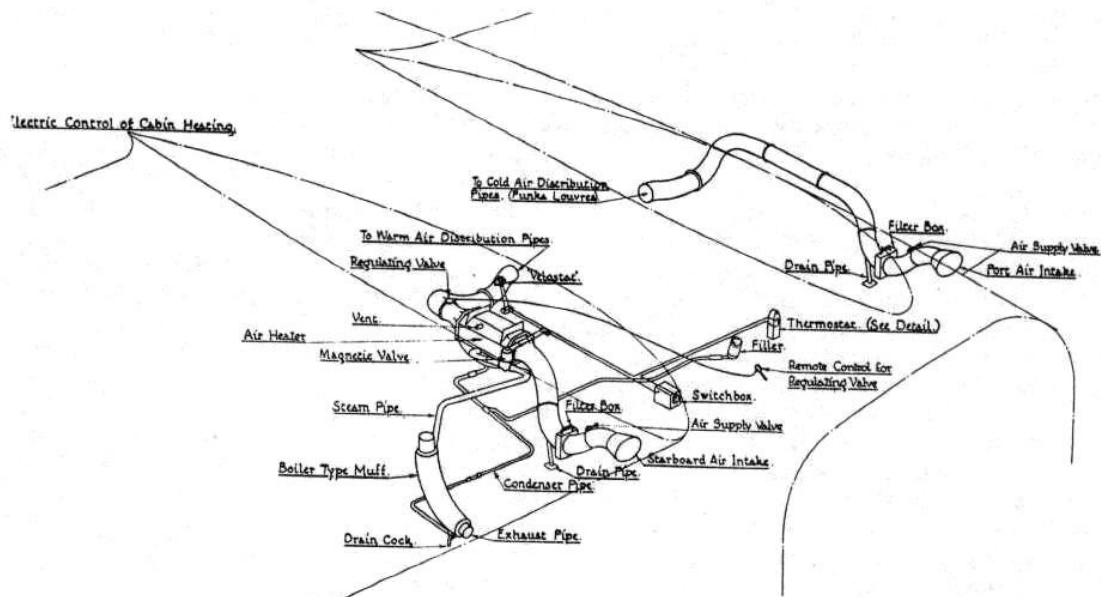
26. Part of Maintenance Manual Diagram 33 showing the heating and ventilating system used on the Mark I S.23 'boats.
